Program Bulletin

CUSTOMER SATISFACTION PROGRAM

SUBJECT: Uneven Police Car Rear Tire Wear – Replace Rear Wheel Spindle Rods

**MODELS: 2007-2008 Chevrolet Impala
Equipped with Police Package (RPO 9C1/9C3)**

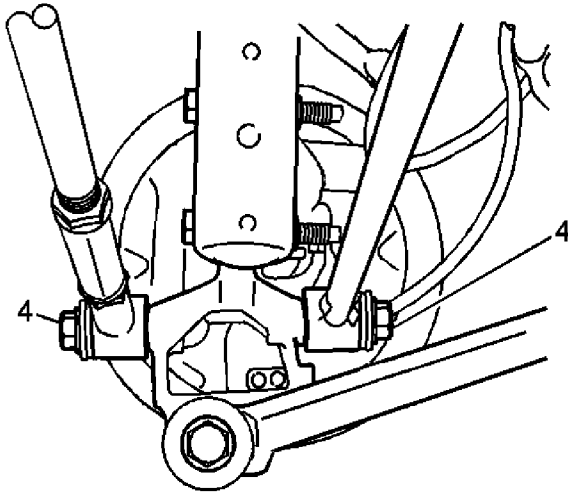
2129076

5. Remove the rear wheel spindle rod bolts (4) and nuts from the knuckles (both sides).
6. Remove the stabilizer shaft from the rear suspension support.
7. Support the rear suspension support with jack stands and remove the mounting bolts.
8. Lower the rear suspension support in order to gain access to the rear wheel spindle rod to support bolts.

15. Install the stabilizer shaft to the rear suspension support.
16. Install the rear wheel spindle rod bolts and nuts to the knuckles (both sides).

Tighten

Tighten the nuts to 150 N·m (110 lb ft).

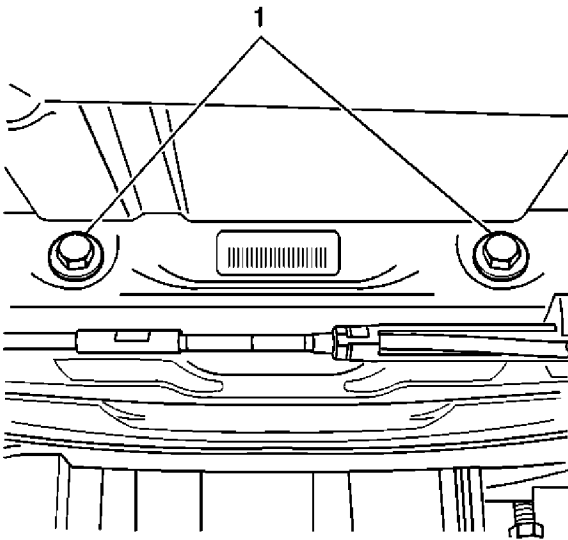
614974

9. Remove the four rear wheels spindle rod bolts (1) and nuts from the rear suspension support.
10. Remove the rear wheel spindle rods from the vehicle.
11. Install the new rear wheel spindle rods to the vehicle.

12. Install the four rear wheel spindle rod bolts and nuts to the rear suspension support.

Tighten

Tighten the bolts to 135 N·m (100 lb ft).
